INDOOR AIR QUALITY ASSESSMENT

Sewage Backup Investigation

**Department of Children and Families
151 West Boylston Street
Worcester, Massachusetts**

Prepared by:
Massachusetts Department of Public Health
Bureau of Environmental Health
Indoor Air Quality Program
February 2018

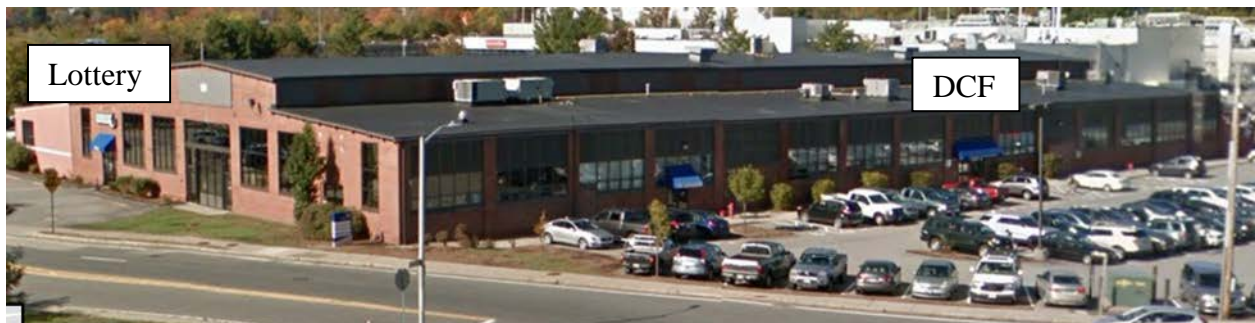
Picture 12

The Mass Lottery has office space in the building as well (Picture 12). It was reported by property management that the building sewer in this section of the building flows by gravity to the sewer line at the street. DCF and lottery officials confirmed reports of multiple backups in this sewer line as well. Unless the backups on the Lottery side of the building were confined to clogs at the fixtures (e.g. toilet), it brings to question the integrity of the building sewer line going out to the street as well as the street sewer line itself. Since there is no ejector pump on this side of the building, it is very likely that there may be recurring problems in the building sewer line (or city line) in this area.

DCF and Lottery locations in the building (*Google Maps*)
